**WEEKLY REPORT**

Contract No./TDD	Project Title / Location	Dates of Report	Report No.
EP-S8-13-01 0001/1502-04 & 1408-01	EPA Region 8 Start IV Contract Red and Bonita Removal/Gold King Mine	7/25/2015	2

**DAILY PRODUCTION & QUALITY CONTROL REPORT**

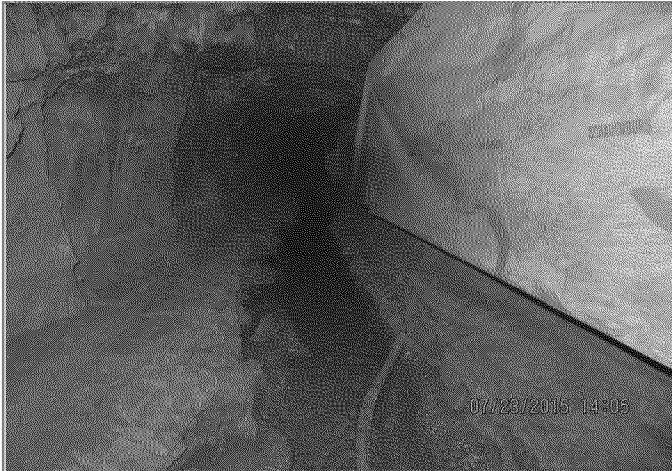
Photo 1

Red and Bonita Tunnel Prior to Removal of Solids.

- MES began in mine solids clean out and as of 7/25 has rough cleaned 177 of required 280 feet.
- MES requested modification to the entrance cap/ceiling to allow ease of entry and exit, work will be conducted 7/27 and 7/28.
- The MES compressor was malfunctioning and the air gun could not be used until 7/24, so cleaning was conducted with a Ramrod.

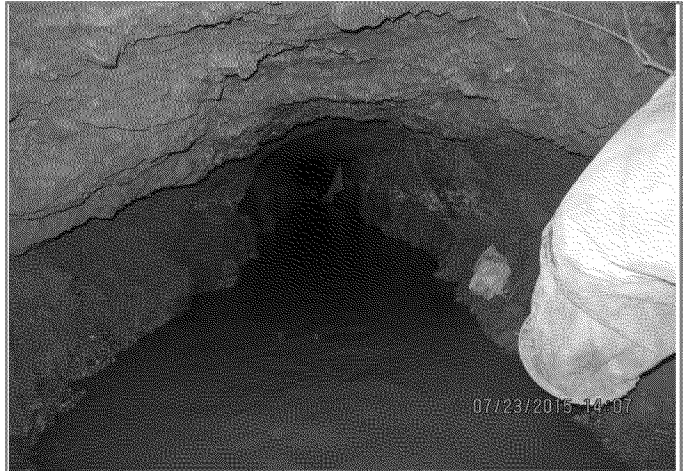
Photo 2

Red and Bonita Tunnel After Rough Removal of Solids, Coloration due to Ongoing Removal of Solids.

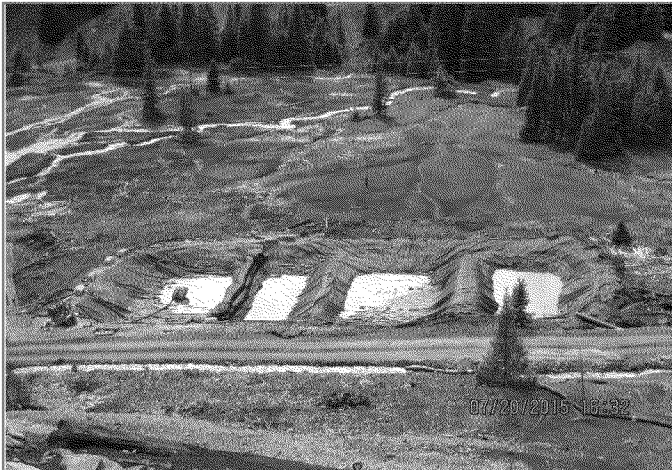
Photo 3

Pond System Overview from top of Red and Bonita Tailings Dump.

- Water Treatment ponds:
 - + Created spillway from ponds in case of pump malfunction.
 - + Installed baffle in pond 1 to slow water velocity at entry to system
 - + Installed baffle in pond 2 to slow cascade of water from pond 1.
- Widened entry road to admit for mobilization of MES.
 - + MES had an equipment delivery after they had left the site and ERRS needed to assist with unloading after hours. An MES truck had a flat tire on the pad at the top of the waste dump and wouldn't start; repairs were completed the following day.
 - + ERRS installed temporary, orange webbing fencing along the road at the treatment ponds.

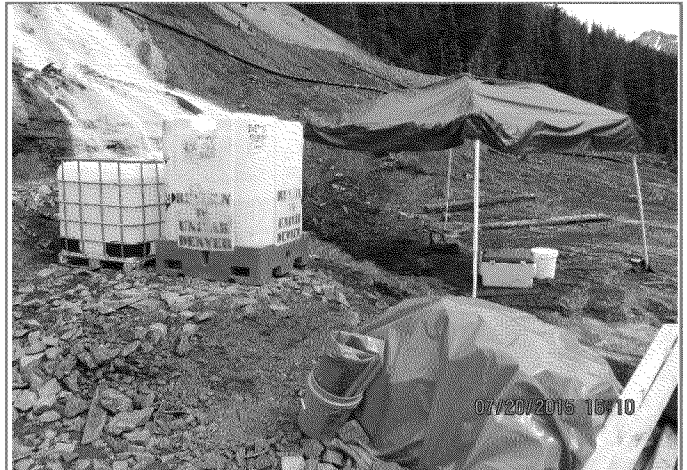
Photo 4

Water Treatment Area Setup, Caustic on the Left, Brennfloc in the Foreground, and the Floc Station on the Background Right.

- Treatment during first mucking was successful. Baffles were added in ponds 1 and 2 to improve settling.
- Approximately 675 gallons of caustic added; 1575 gallons of caustic remaining.
- Approximately 2 bags of Brennfloc used; 10 bags of Brennfloc remaining.
- Upped floc addition to 1 turn/min to improve settling after larger quantities of solids were released from the mine.
- ERRS has been instructed on water treatment methods and has started assisting START.

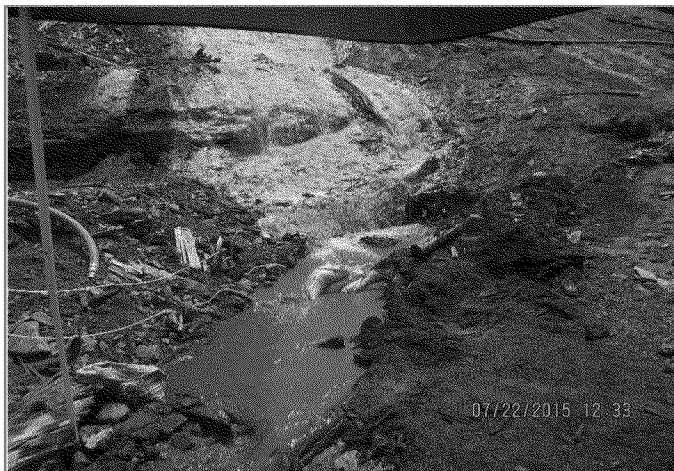
Photo 5

Water Treatment On-going, Caustic Addition on the Left.

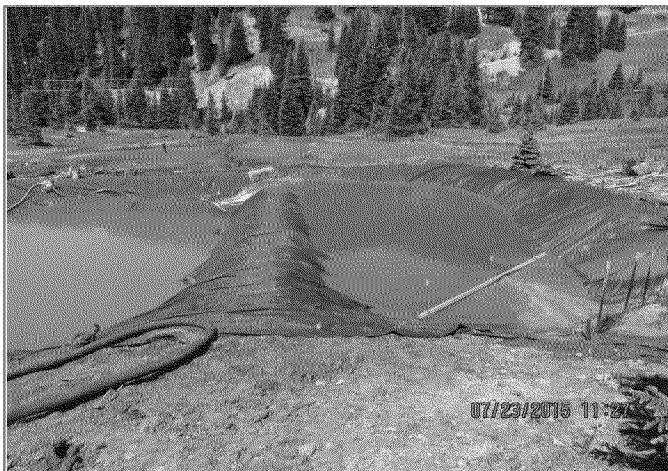
Photo 6

Water Treatment Settling Ponds, Right Pond is the 1st Pond in the Series of 4. Note Clarity Difference in Pond 2.

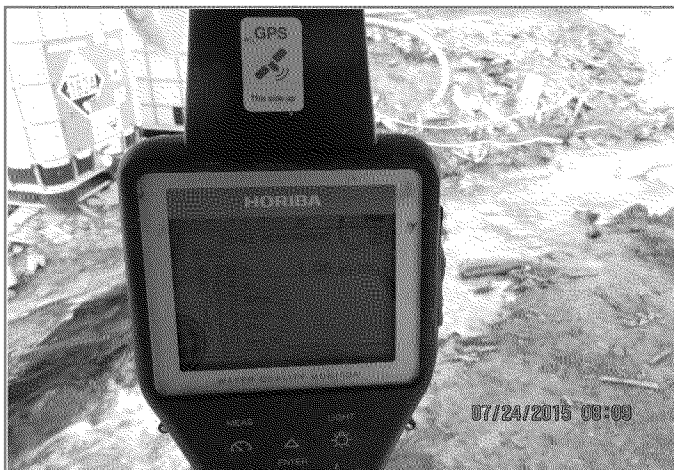
Photo 7

Water Quality of Mine Discharge before Mine Entry, pH = 6.28 and Turbidity 5.8 NTU.

- Effluent sample collected from Red and Bonita water treatment system and sent to commercial lab.
- Mine water pH prior to mine entry varies from 6.2 - 5.8 and turbidity from 6 - 42 NTU.
- Effluent pH varies from 6.1 - 7.3 and turbidity from 36 - 42 NTU.

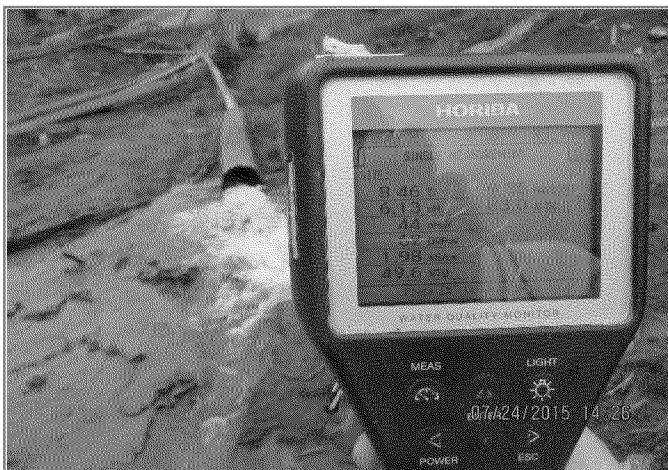
Photo 8

Water Quality of Treatment Effluent, pH = 6.13 and Turbidity 49.6 NTU.
